UPPER HUDSON RIVER BASIN
MECHANICVILLE RESERVOIR DAM

SARATOGA COUNTY, NEW YORK
INVENTORY NO. N.Y. 1061

PHASE 1 INSPECTION REPORT
NATIONAL DAM SAFETY PROGRAM

Phase I Inspection Report
National Dam Safety Program
Mechanicville Reservoir Dam
I.D. No. NY-1061
#225A-142 Upper Hudson River Basin
Saratoga County, New York

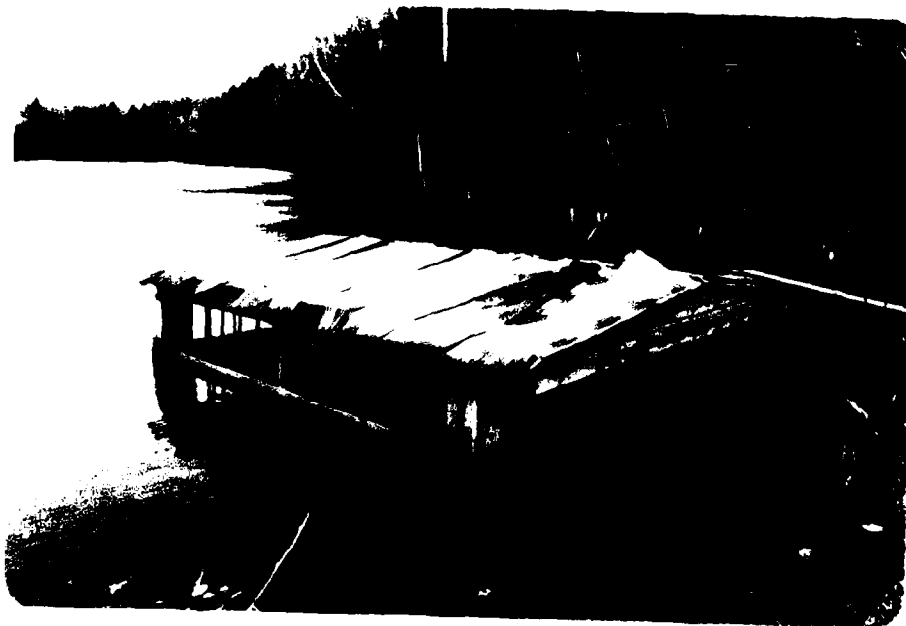
Drop Inlet Structure; Note Stop Logs in Place
on all Sides.

- a. Due to the serious deficiency in spillway capacity, remove the stop logs and lower the reservoir level pending the results of the detailed hydrologic/hydraulic analysis.
